**UNITED STATES ENVIRONMENTAL PROTECTION AGENCY
REGION IX**

Purpose: RCRA Compliance Evaluation Inspection

Facility: Semiray Special Processes

Date of Inspection: October 30, 2014
Time In/Time Out 11:40 AM – 2:00 PM

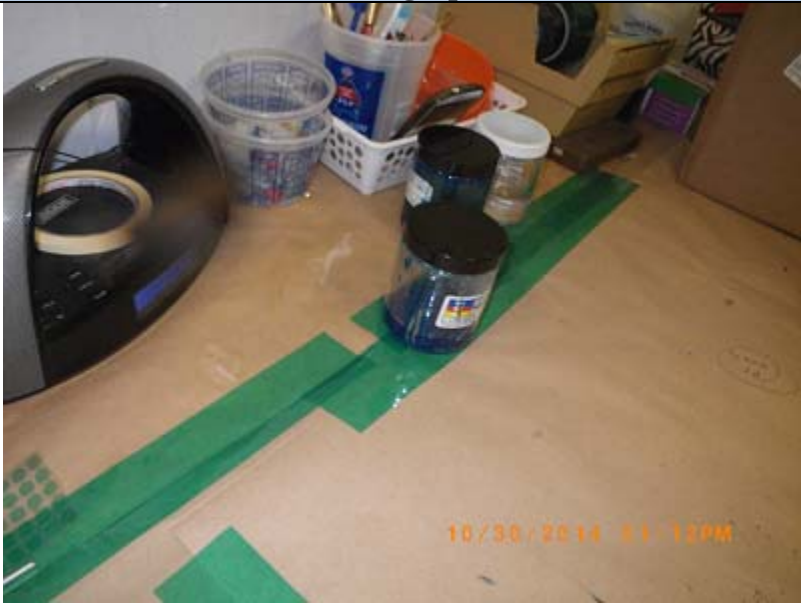
Observation	Photograph
1. Containers used to hold waste thinner (D001) located at the indoor anodizing and masking area. The containers were not labeled.

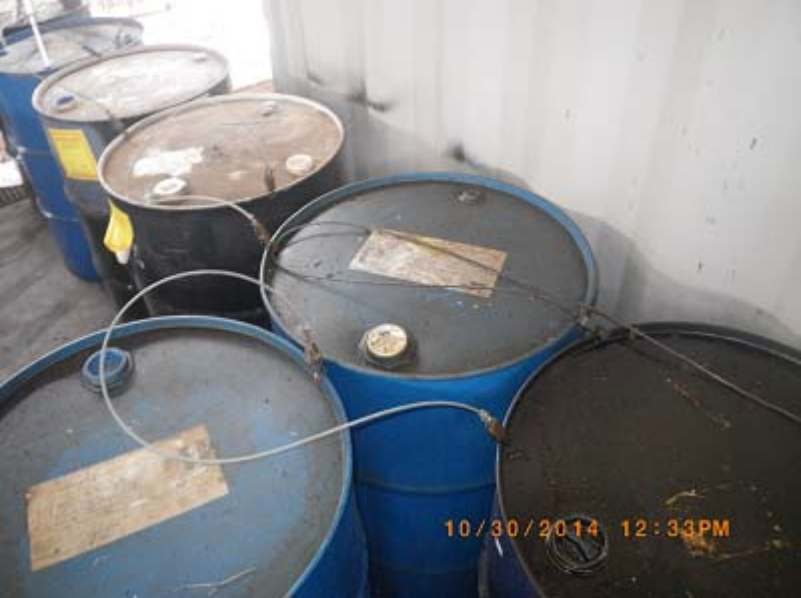
<p data-bbox="883 831 1115 863">No. 4 (IMGP3864)</p>

Observation	Photograph
<p>4. <i>The three containers in the foreground of this photo were unlabeled. Mr. Rademaker stated that they are flammable liquids (likely IPA or acetone and methyl ethyl ketone.)</i></p> <p><i>Based off of Semiray's previous manifests, the flammable liquids are likely acetone and methyl ethyl ketone (D001 and/or D035, F003 and F005.)</i></p> <p><i>Note that the containers are unlabeled and there is no aisle space to inspect the containers. .</i></p>

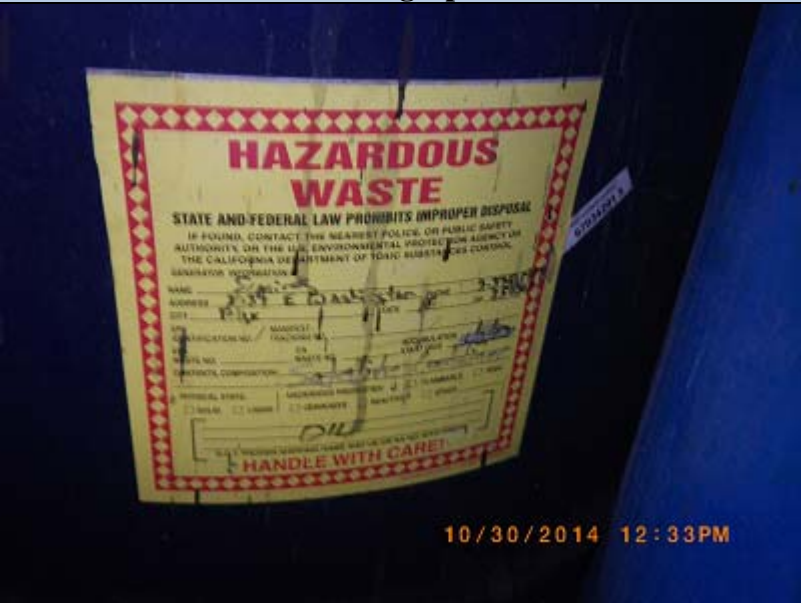
Observation	Photograph
<p>5. <i>Partially legible hazardous waste label on a container in the HWAA labeled “Satellite Container.” Inspectors observed satellite containers used at the facility to collect waste thinner and isopropyl alcohol (D001). The accumulation start date on this label is illegible but appears to be 6/3/2013.</i></p>

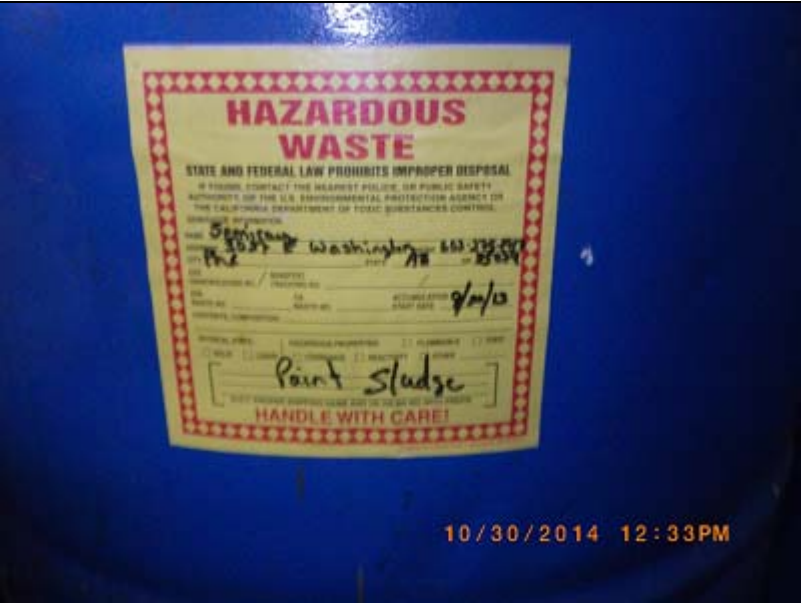
<p>No. 6 (IMGP3866)</p>

<p>No. 5 (IMGP3865)</p>
<p>6. <i>Hazardous waste label on a container shown in IMGP3859 for “Paint Sludge” with an accumulation start date of 9/20/2013 (accumulated for 405 days, 315 days beyond 90 days at the time of the inspection.)</i></p> <p><i>Based off of Semiray’s previous manifests, paint sludge is likely D001 and/or D007, D018, D035, D039, F003 and F005.</i></p>

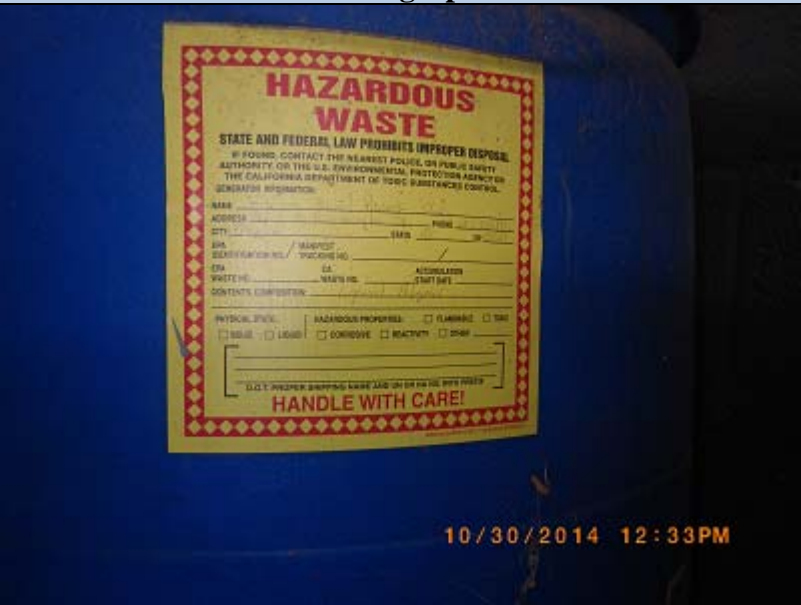
Observation	Photograph
<p>7. Hazardous waste label on a container shown in IMGP3859 for “Liquid Polymer” without an accumulation start date.</p> <p>EPA could not determine an appropriate</p>

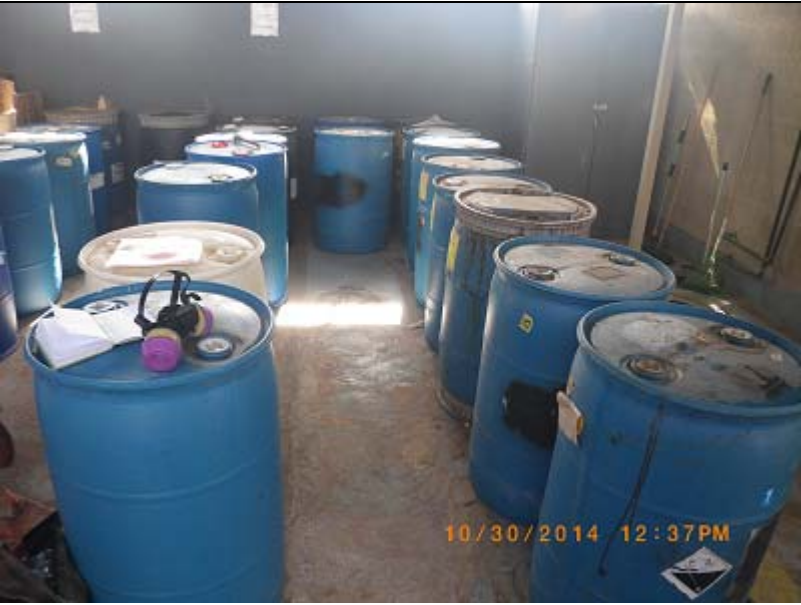
<p>No. 8 (IMGP3869)</p>

<p>No. 7 (IMGP3867)</p>
<p>8. Overview photo of metal plating and chrome waste containers in the HWAA.</p> <p>Based off of Semiray’s previous manifests, the chrome waste is likely D002 and/or D007 and F006.</p> <p>Note that the container with the black mark in the center / background in this photo does not have a label.</p>

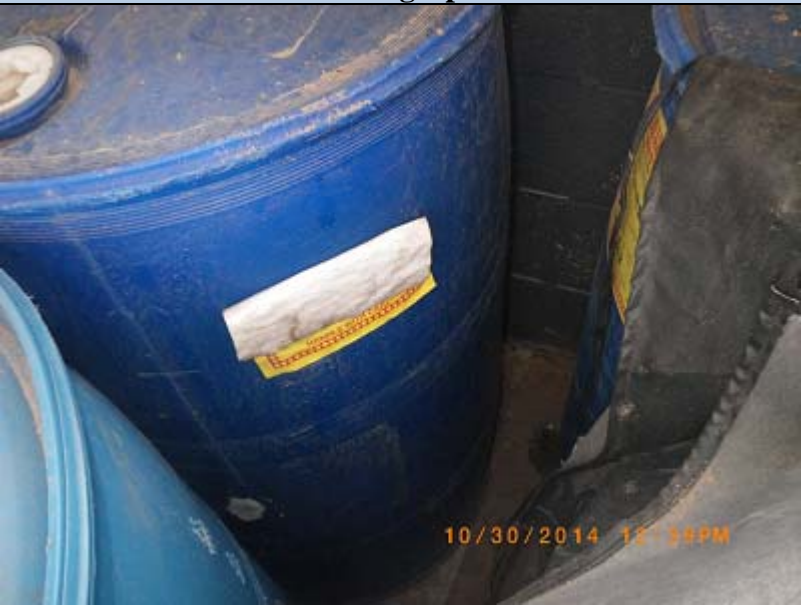
Observation	Photograph
<p>9. Close up of one of the containers shown in IMGP3869. Note the label had folded onto itself and was peeling from the container.</p>

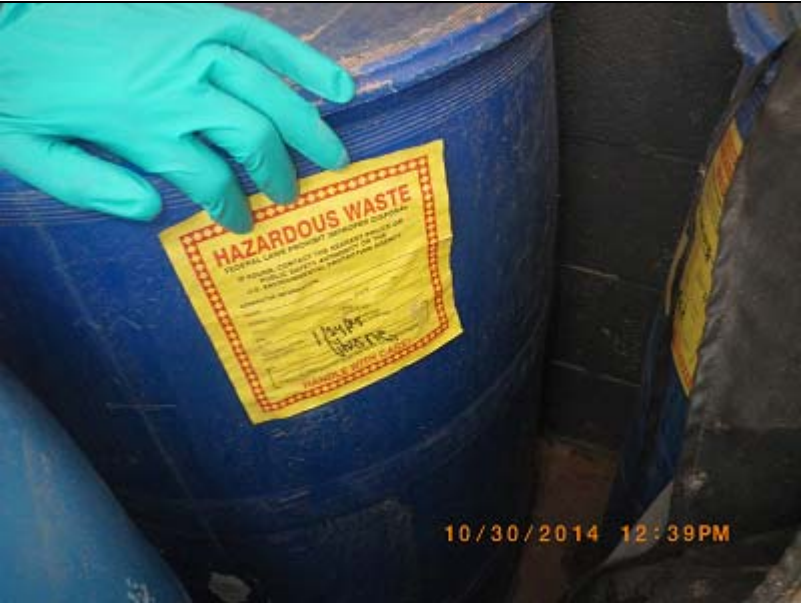
<p>No. 10 (IMGP3872)</p>

<p>No. 9 (IMGP3871)</p>
<p>10. Close up of the label shown in IMGP3871. The label describes the contents as "Chrome" with an accumulation start date of 1/24/2014 (accumulated for 279 days, 189 days beyond 90 days at the time of the inspection.</p> <p>Based off of Semiray's previous manifests, the chrome waste is likely D002 and/or D007 and F006.</p>

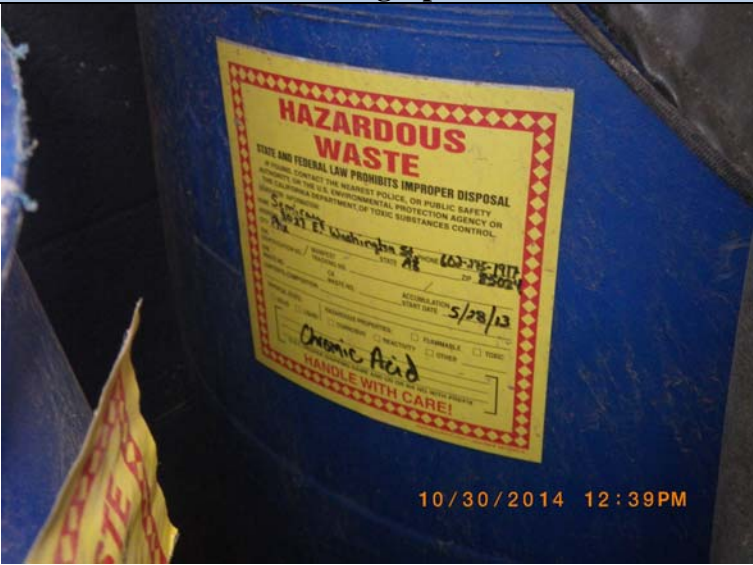
Observation	Photograph
<p>11. Close up of the label shown in IMGP3869. The label describes the contents as “Chromic Acid” with an accumulation start date of 5/28/2013 (accumulated for 520 days, 430 days beyond 90 days at the time of the inspection.)</p> <p>Based off of Semiray’s previous manifests, the chrome waste is likely D002 and/or D007 and F006.</p>

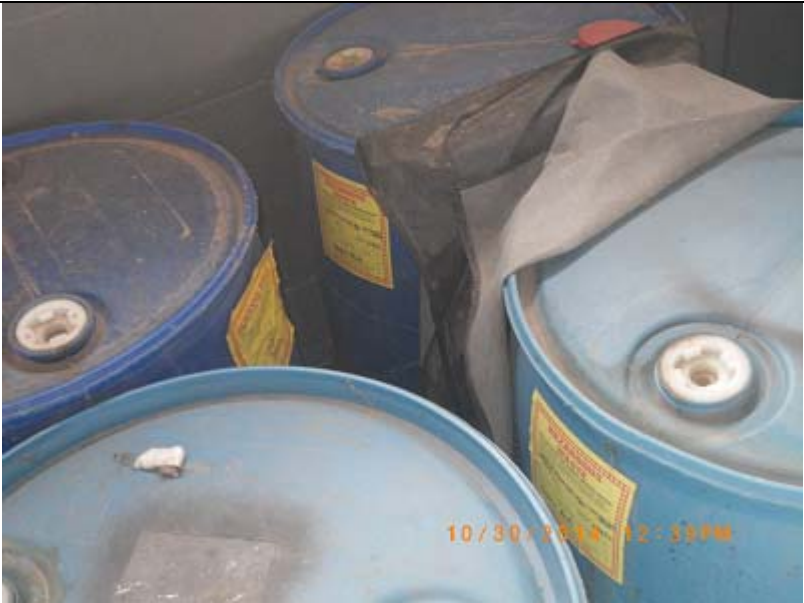
<p>No. 12 (IMGP3874)</p>

<p>No. 11 (IMGP3873)</p>
<p>12. Close up of chromic acid waste. Close up of the container labels are shown in the following photos.</p> <p>Based off of Semiray’s previous manifests, the chrome waste is likely D002 and/or D007 and F006.</p> <p>Note the lack of aisle space.</p>

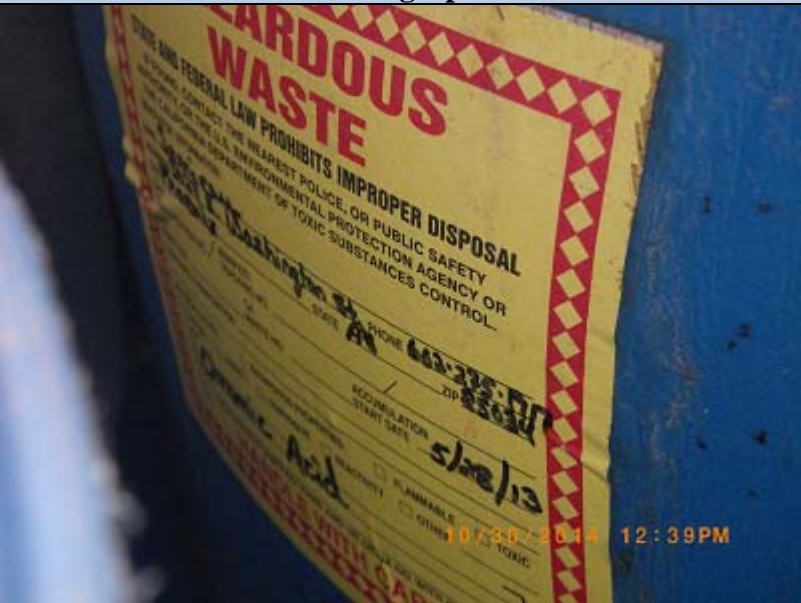
<p>No. 13 (IMGP3875)</p>

Observation	Photograph
<p>13. Close up of a label affixed to a 55-gallon container, labeled "Chromic Acid" with an accumulation start date of 5/28/2013 (accumulated for 520 days, 430 days beyond 90 days at the time of the inspection.)</p> <p>Based off of Semiray's previous manifests, the chrome waste is likely D002 and/or D007 and F006.</p> <p>This is a separate container than the one shown in IMGP3873, which has identical contents and accumulation start date.</p>

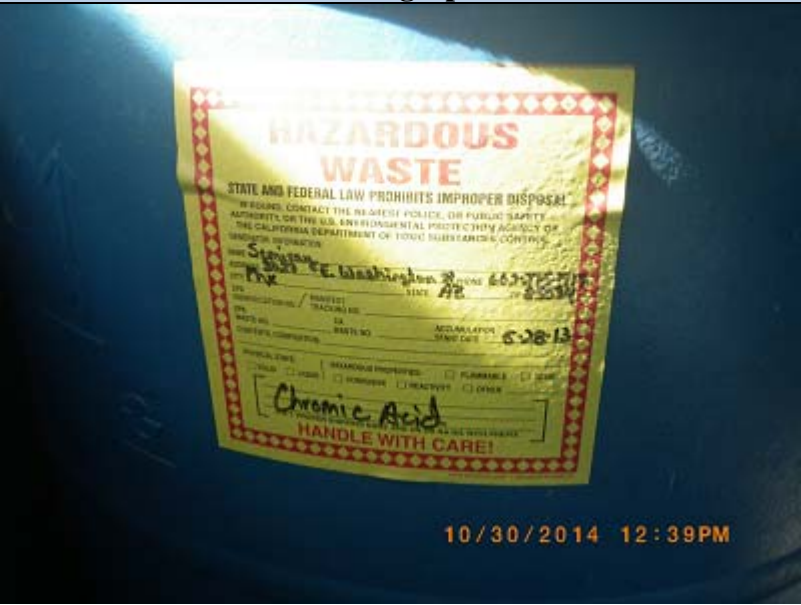
<p>No. 14 (IMGP3876)</p>

Observation	Photograph
<p>14. Close up of a label affixed to a 55-gallon container, labeled "Chromic Acid" with an accumulation start date of 5/28/2013 (accumulated for 520 days, 430 days beyond 90 days at the time of the inspection.)</p> <p>Based off of Semiray's previous manifests, the chrome waste is likely D002 and/or D007 and F006.</p> <p>This is a separate container than the one shown in IMGP3873 and IMGP3875, which have identical contents and accumulation start dates.</p>

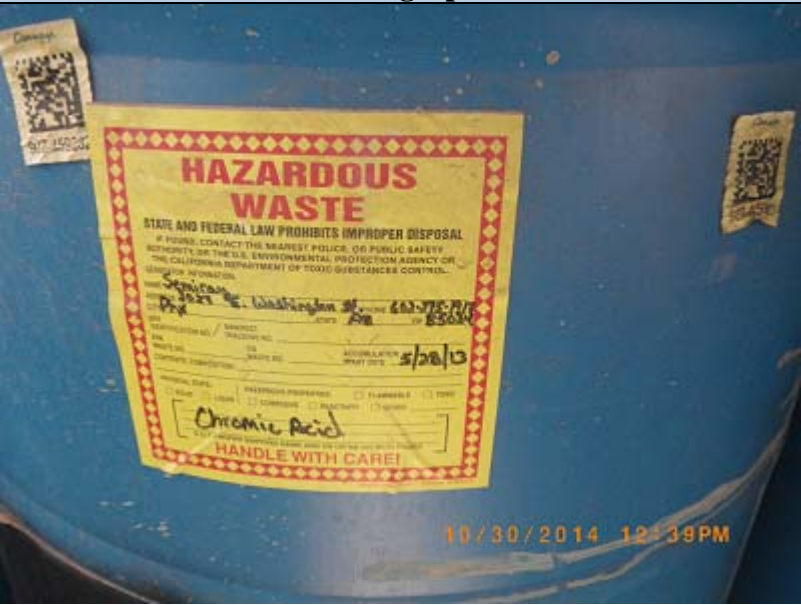
<p>No. 15 (IMGP3877)</p>

Observation	Photograph
<p>15. Close up of a label affixed to a 55-gallon container, labeled "Chromic Acid" with an accumulation start date of 5/28/2013 (accumulated for 520 days, 430 days beyond 90 days at the time of the inspection.)</p> <p>Based off of Semiray's previous manifests, the chrome waste is likely D002 and/or D007 and F006.</p> <p>This is a separate container than the one shown in IMGP3873, IMGP3875 and IMGP3876, which have identical contents and accumulation start dates.</p>

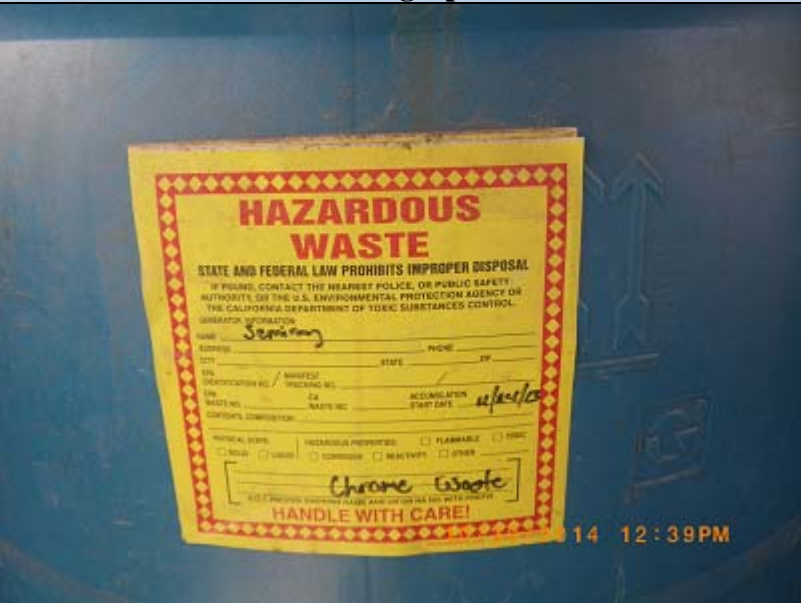
<p>No. 16 (IMGP3878)</p>

Observation	Photograph
<p>16. Close up of a label affixed to a 55-gallon container, labeled "Chrome Waste" (D007) with an accumulation start date of 11/14/2013 (accumulated for 350 days, 260 days beyond 90 days at the time of the inspection.</p> <p>Based off of Semiray's previous manifests, the chrome waste is likely D002 and/or D007 and F006.</p>

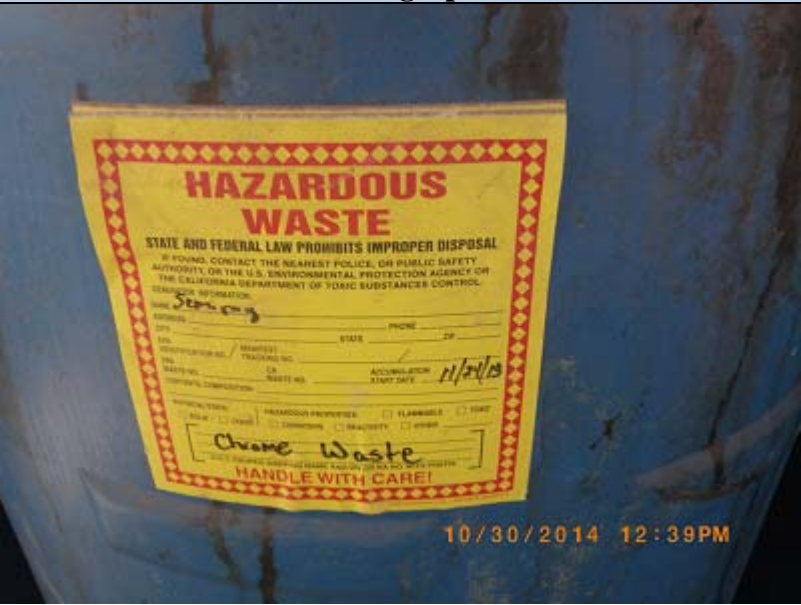
<p>No. 17 (IMGP3879)</p>

Observation	Photograph
<p>17. Close up of a label on an additional container shown in IMGP3869. The label describes the contents as “Chrome Waste” with an accumulation start date of 11/14/2013 (accumulated for 350 days, 260 days beyond 90 days at the time of the inspection.)</p> <p>Based off of Semiray’s previous manifests, the chrome waste is likely D002 and/or D007 and F006.</p> <p>This is a separate container than the one shown in IMGP3878, which has identical contents and accumulation start dates</p>

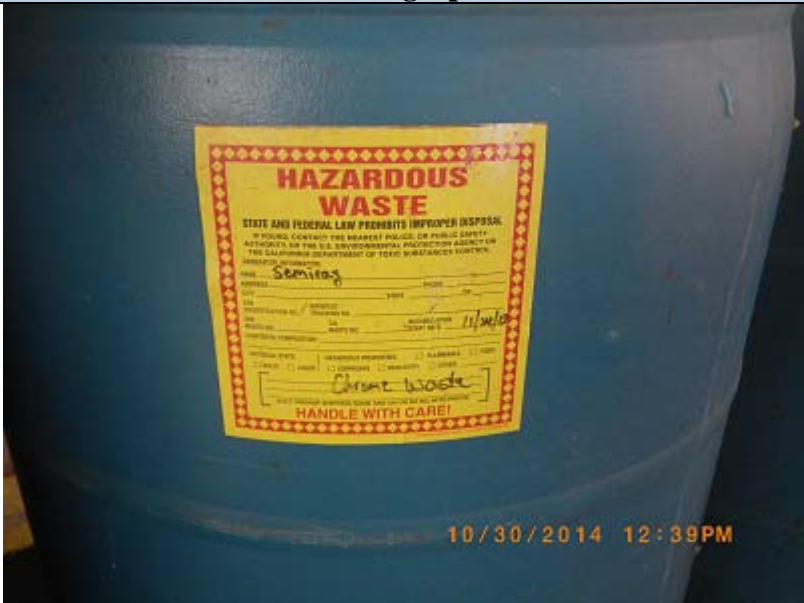
<p>No. 18 (IMGP3880)</p>

Observation	Photograph
<p>18. Close up of a label on an additional container shown in IMGP3869. The label describes the contents as “Chrome Waste” with an accumulation start date of 11/14/2013 (accumulated for 350 days, 260 days beyond 90 days at the time of the inspection.).</p> <p>Based off of Semiray’s previous manifests, the chrome waste is likely D002 and/or D007 and F006.</p> <p>This is a separate container than the one shown in IMGP3878 and IMGP3879, which have identical contents and accumulation start dates.</p>

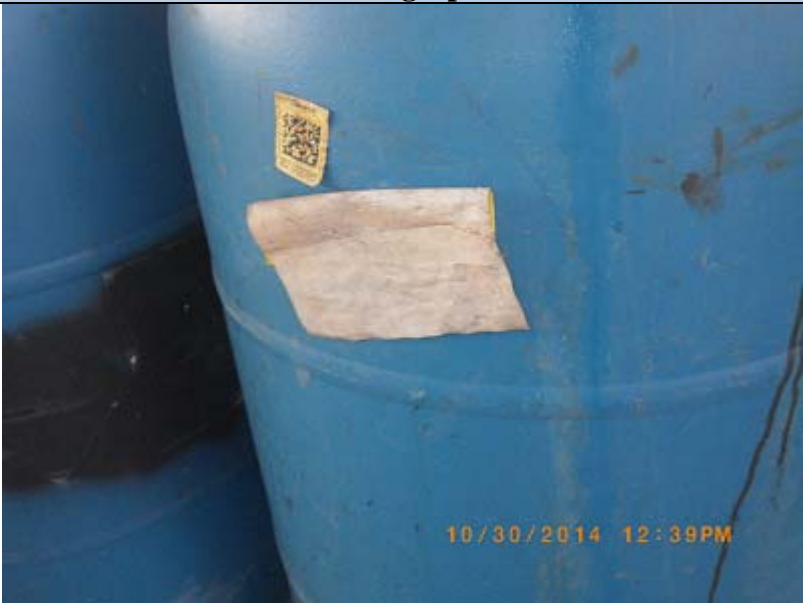
Observation	Photograph
<p>19. Label falling off of one of the containers shown in IMGP3869. Note that this is a different container than IMGP3871, which also had a label peeling off.</p>

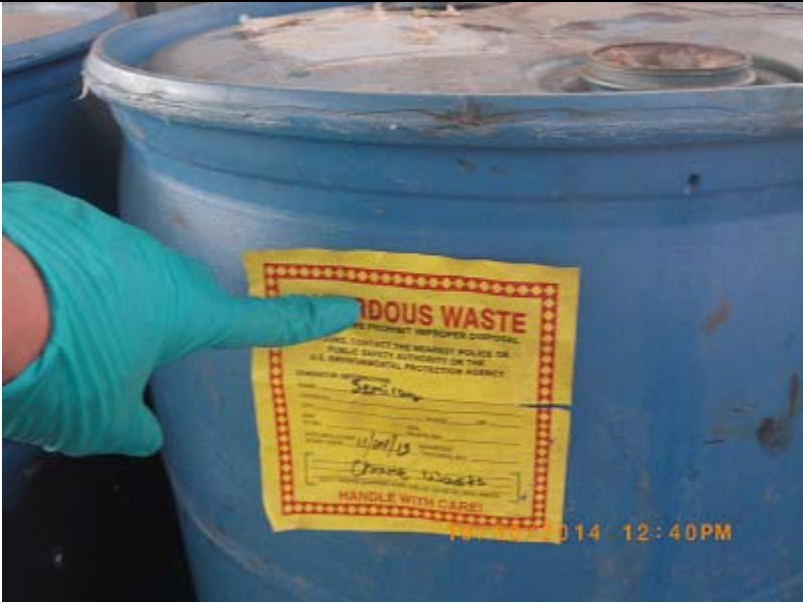
<p>No. 20 (IMGP3882)</p>

<p>No. 19 (IMGP3881)</p>
<p>20. Label on container shown in IMGP3881. The label describes the contents as "Chrome Waste" with an accumulation start date of 11/14/2013 (accumulated for 350 days, 260 days beyond 90 days at the time of the inspection.)</p> <p>Based off of Semiray's previous manifests, the chrome waste is likely D002 and/or D007 and F006.</p>

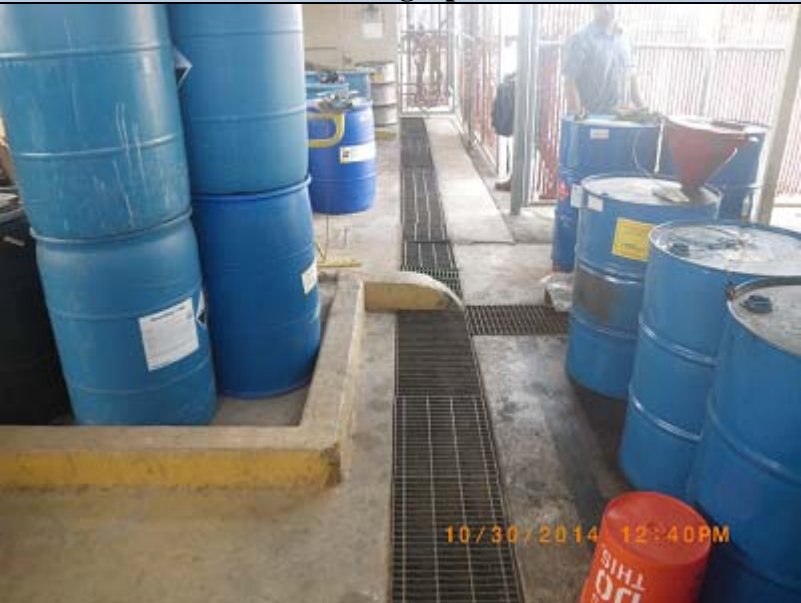
<p data-bbox="873 831 1122 863">No. 21 (IMGP3883)</p>

Observation	Photograph
<p data-bbox="235 233 521 594"><i>21. Floor drainage system in the HWAA. Mr. Rademaker explained that this drainage system empties into a retention basin shown in IMGP3886.</i></p> <p data-bbox="280 636 529 1035"><i>Note the unlatched funnel (open container) on container on the right of the photo, which had a hazardous waste sticker labeled “10/30/2014 Flammable Liquids”.</i></p> <p data-bbox="280 1077 534 1392"><i>Based off of Semiray’s recent manifests, the flammable liquids are likely Acetone and Methyl ethyl ketone (D001 and/or D035, F003 and F005.)</i></p>

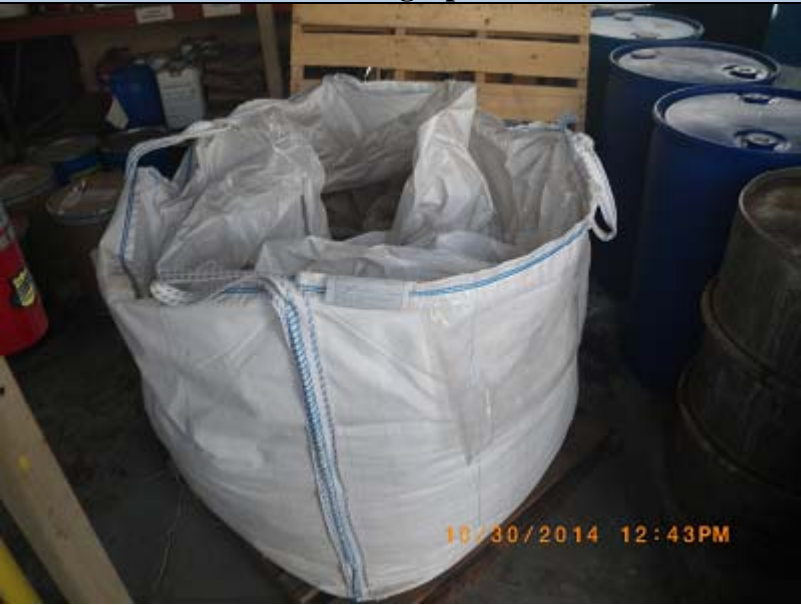
Observation	Photograph
<p>23. Super-Sack of filter cake sludge (F006) from the facility's on-site wastewater treatment unit, accumulated in the HWAA. Note that the container is not marked or dated and is not closed.</p>

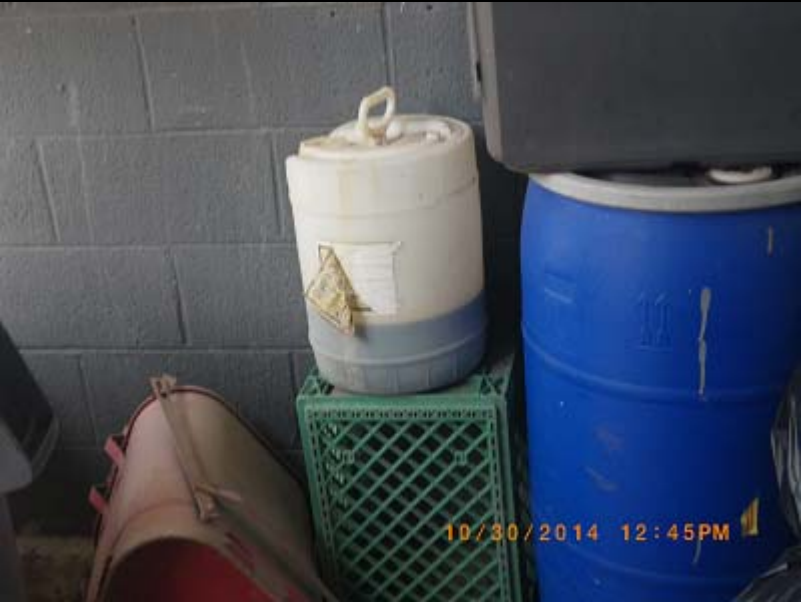
<p>No. 24 (IMGP3891)</p>

<p>No. 23 (IMGP3887)</p>
<p>24. White container with unknown contents.</p> <p>EPA did not take a photo of the face-side of the peeling label at the time of the inspection due to time constraints.</p>

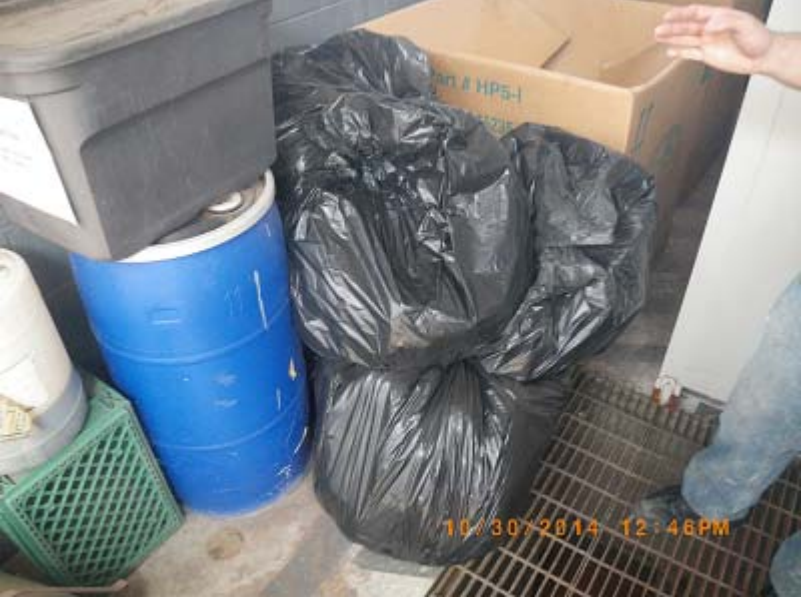
<p data-bbox="873 831 1123 863">No. 25 (IMGP3892)</p>

Observation	Photograph
<p>25. <i>Black plastic garbage bags containing paint booth filters, which Mr. Rademaker stated are hazardous for chrome (D007). The black garbage bags are not adequate containers and these hazardous wastes are not being managed to prevent release to the environment or to protect worker safety. Note that there are no labels with hazardous waste accumulation start dates. .</i></p>

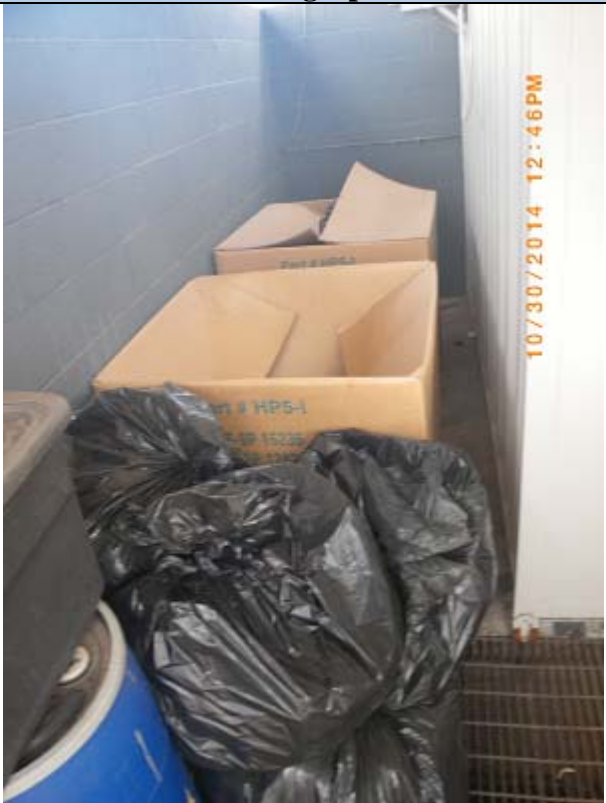
Observation	Photograph
<p>26. Photo of the bags of air filters shown in IMGP3892. The two additional boxes behind the bags contain additional bags of waste air filters, which are hazardous for chrome, according to Mr. Rademaker. The boxes and bags were not labeled, dated and were not adequately closed.</p>

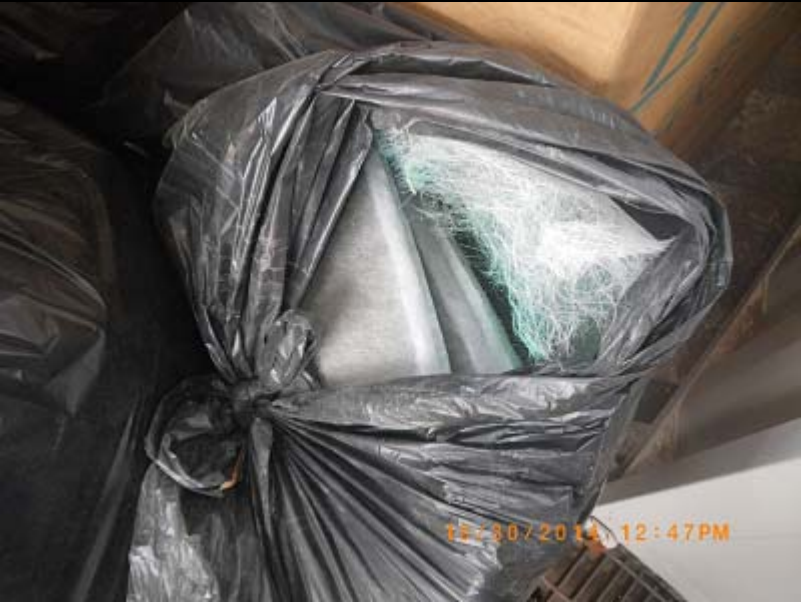
<p>No. 27 (IMGP3895)</p>

<p>No. 26 (IMGP3894)</p>
<p>27. Close up of the paint booth filters shown in IMGP3892. Note that Mr. Rademaker opened the bag during the inspection to show the contents.</p>

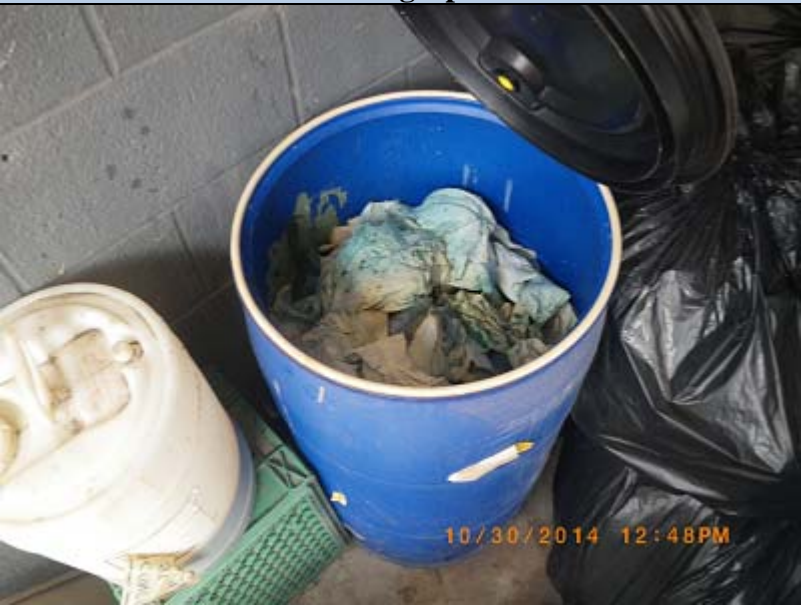
<p>No. 28 (IMGP3898)</p>

Observation	Photograph
<p>28. Contents of the container shown in IMGP3896 showing what appear to be contaminated rags and personal protective equipment. During a 11/19/2014 phone call with EPA inspector Rick Sakow on 11/19/2014, Mr. Rademaker stated that the label shown on this container was torn off and only a portion of the label remained on the container.</p> <p>In their 12/11/2014 response to EPA's information request, Semiray reported that these waste used wipes are hazardous for methyl ethyl ketone (D035, F005), chromium (D007), acetone (F003), n-butyl acetate, toluene (F005) and xylene (F003).</p>

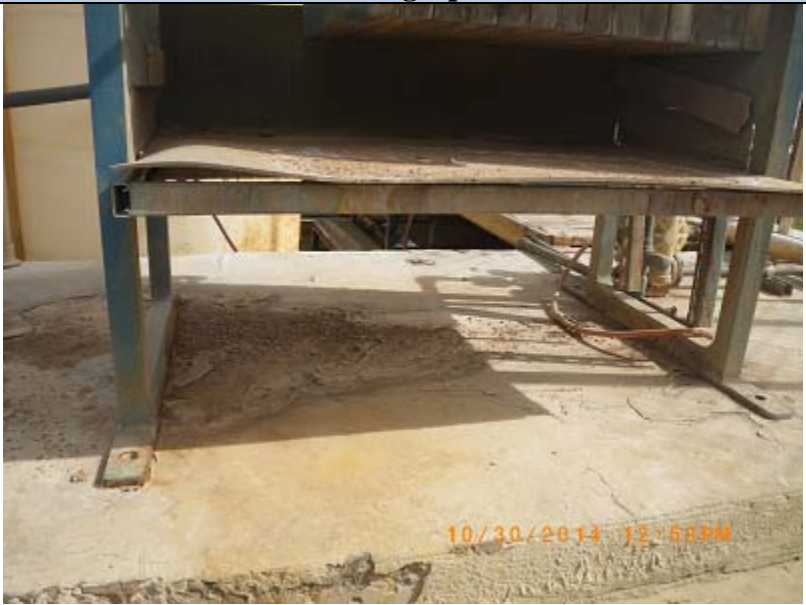
Observation	Photograph
<p>5. Close up of accumulated filter cake waste (F006) within and below the filter press unit.</p>

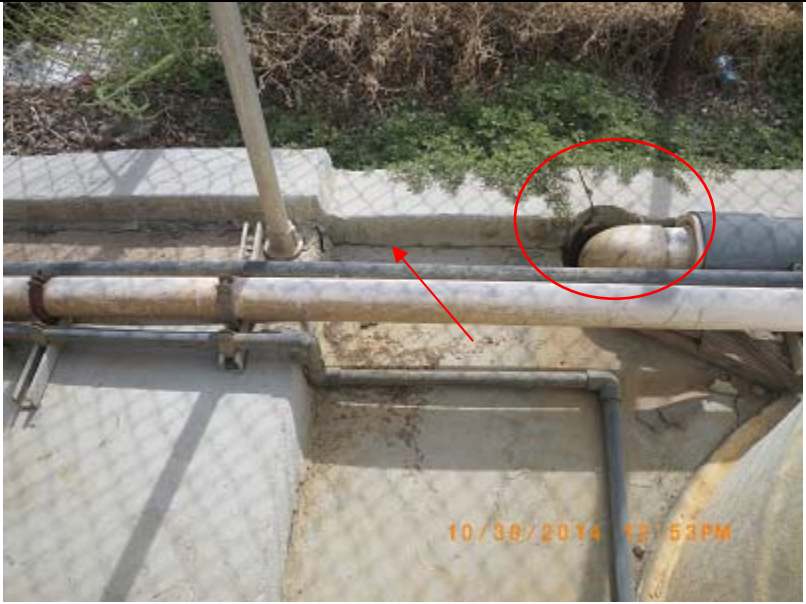
<p>No. 6 (IMGP3907)</p>

<p>No. 5 (IMGP3906)</p>
<p>6. View of the secondary containment berm surrounding the filter press and wastewater treatment unit. Note the crack, circled in red (approximately 2 mm) which runs through the berm. This crack is located along the facility's southernmost perimeter. Also note the accumulated filter cake residue on the surface and the deterioration and cracks in the surface coating.</p>

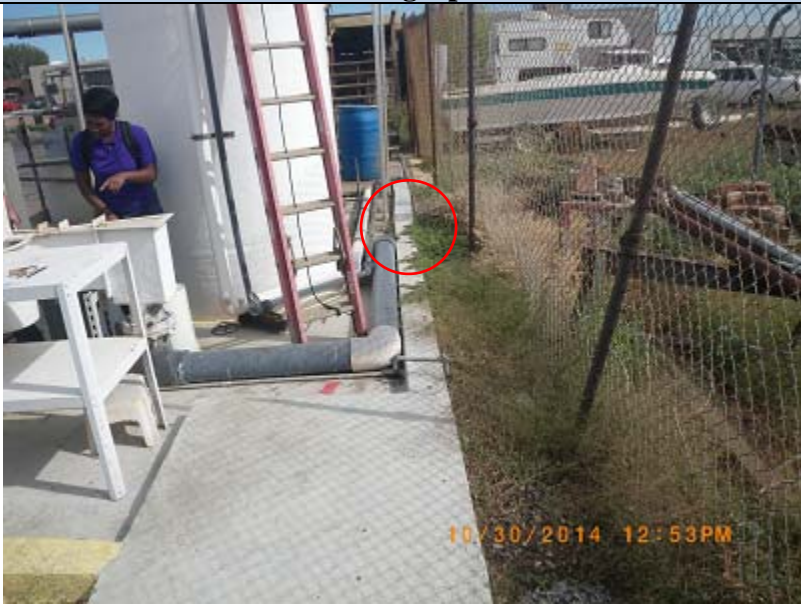
Observation	Photograph
<p>7. <i>View of the bermed wastewater treatment unit and filter press area. Photo was taken facing east. The location of the crack in the berm shown in IMGP3907 is circled in red on this photo.</i></p>

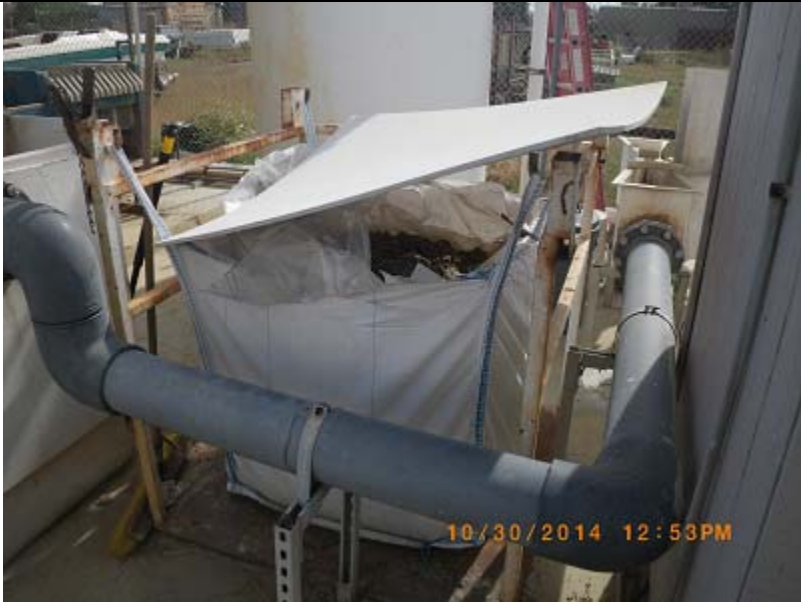
<p>No. 8 (IMGP3909)</p>

<p>No. 7 (IMGP3908)</p>
<p>8. <i>Super-Sack of F006 filter cake sludge accumulated located within the facility's wastewater treatment unit area. The Super-Sack was not labeled, dated or closed.</i></p>

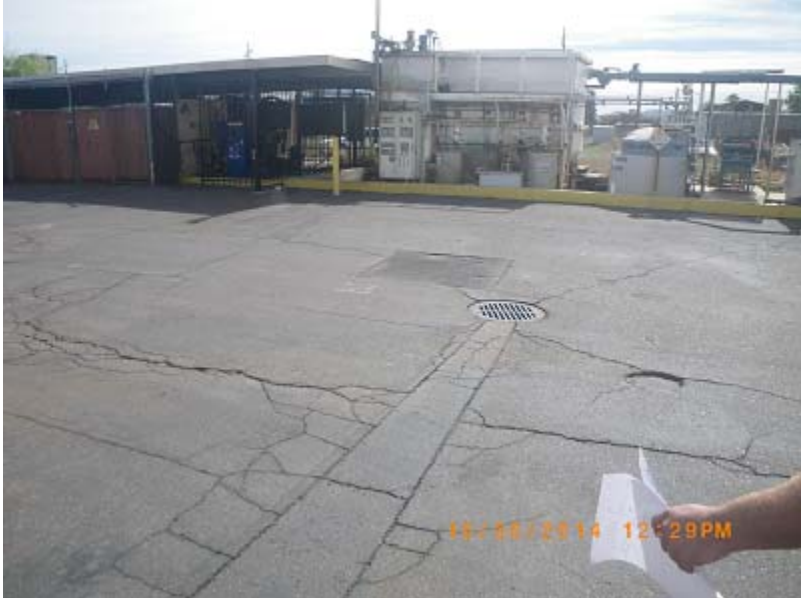
Observation	Photograph
<p>1. View of an inlet located immediately north of the facility's wastewater treatment unit and northwest of the HWAA (shown in the left of this photo). Mr. Rademaker was unsure if this drain discharged to a drywell or to a storm water conveyance system (MS4).</p>

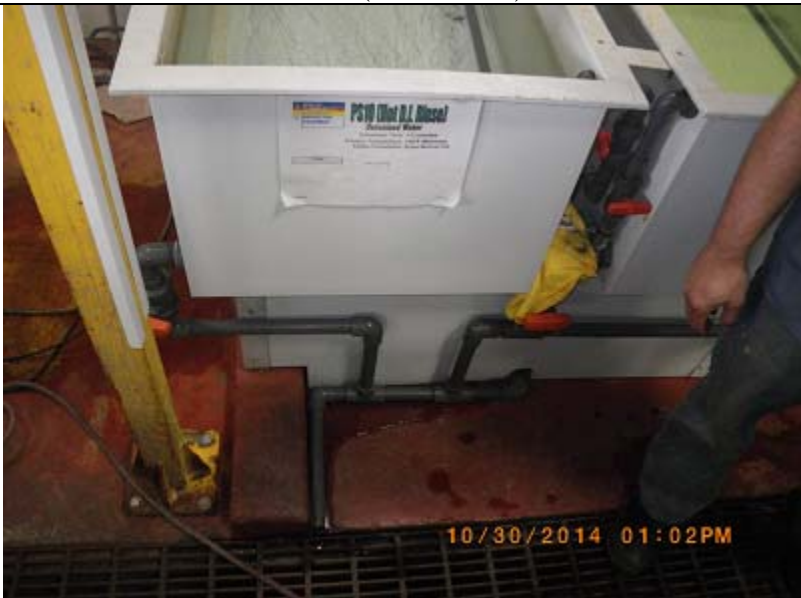
<p>No. 2 (IMGP3918)</p>

<p>No. 1 (IMGP3856)</p>
<p>2. Discharge from plating bath waste through a leaking pipe into the floor's drainage system. The plating bath drainage pipes shown in grey appear to be interconnected and inspectors were unable to discern which plating bath this liquid had discharged from.</p>

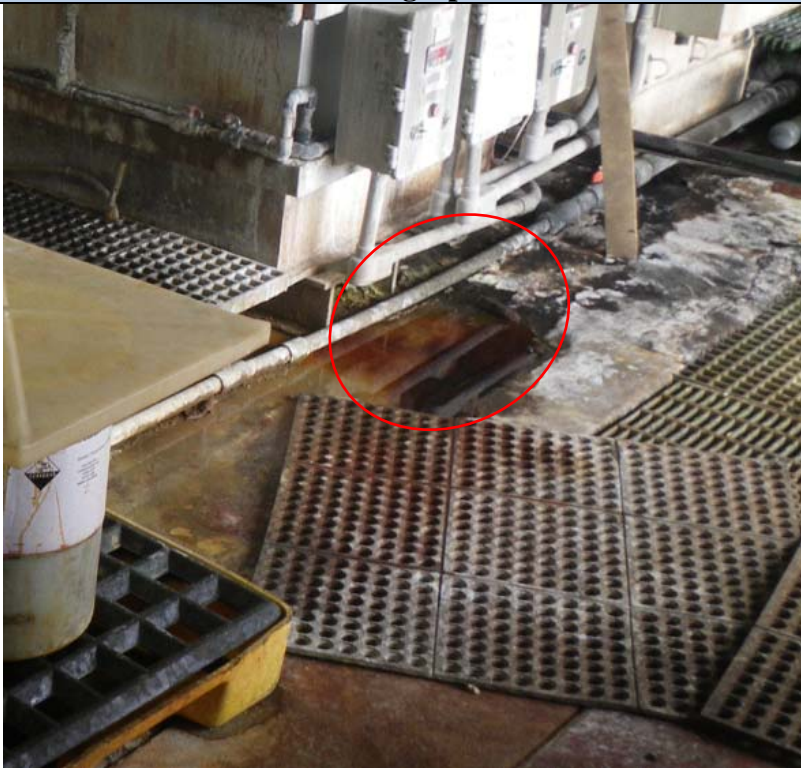
Observation	Photograph
3. Accumulated plating / anodizing bath liquid waste on the floor (circled in red). Note the evidence of previous staining.

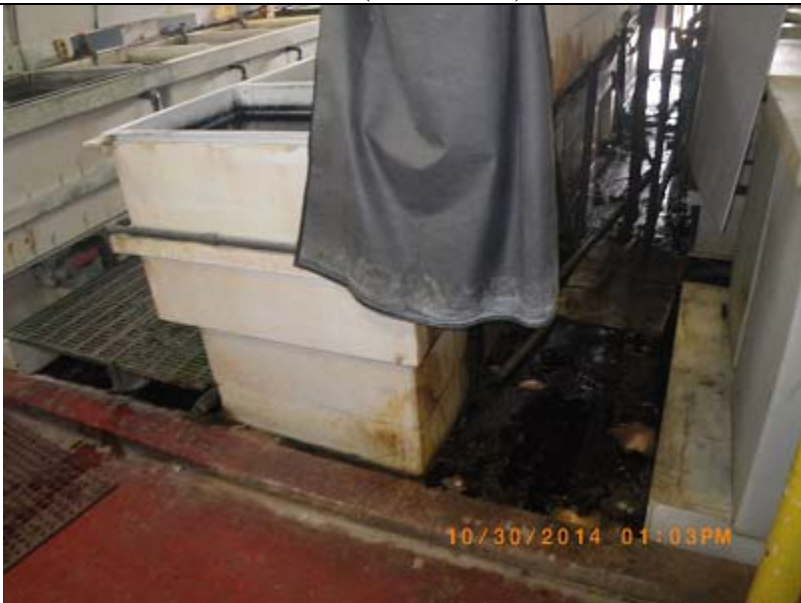
<p>No. 4 (IMGP3920)</p>

<p>No. 3 (IMGP3919)</p>
4. Accumulated plating / anodizing bath liquid waste located behind the plating bath units. The liquid could potentially carry the D002 and/or D007 and F006 waste codes, depending on the contents of the tanks.

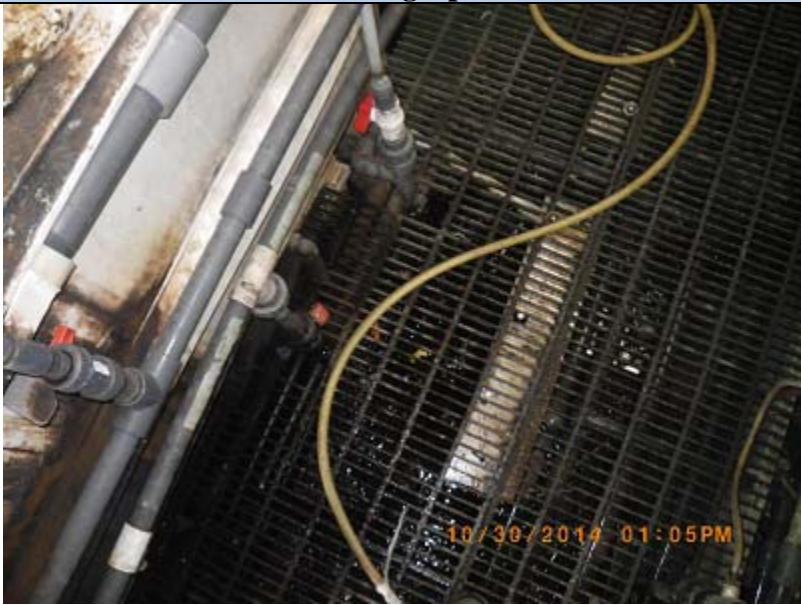
Observation	Photograph
<p>5. Accumulated plating / anodizing bath liquid waste located in the facility's drainage gutters. Mr. Rademaker stated during the inspection that this the level of liquid in the drainages is average and that the drainages are cleaned approximately every 3 months.</p>

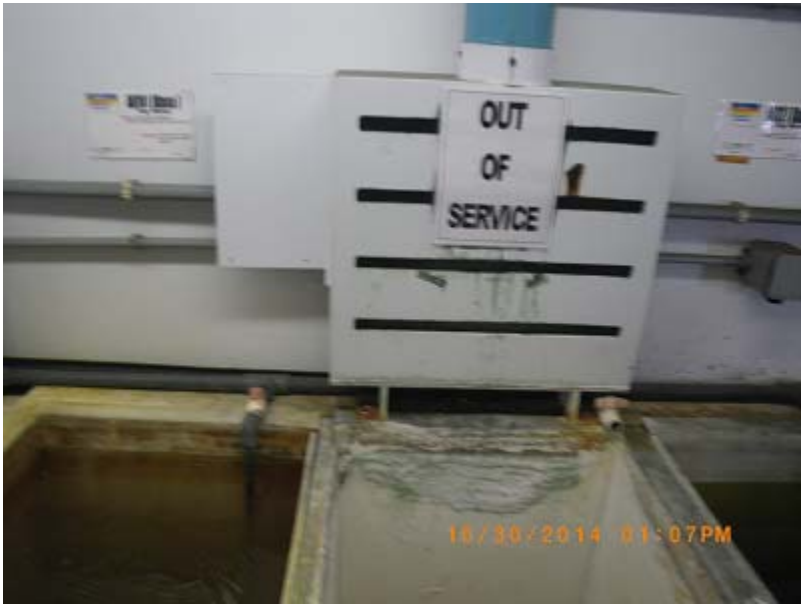
<p data-bbox="911 1499 1154 1535">No. 6 (IMGP3937)</p>

<p data-bbox="911 827 1154 863">No. 5 (IMGP3933)</p>
<p>6. Plating / anodizing bath with an "OUT OF SERVICE" sign. In an 11/21/2014 email to Rick Sakow, Mr. Rademaker stated the tank was taken out of service for routine maintenance due to solid build up around the tank. The solids at the bottom of the tank are crystallization formed due to an acid etch operation that chemically removes calculated aluminum based on an etch rate requirement. When the tank is in process, it's a nitric / HF aluminum etch.</p>

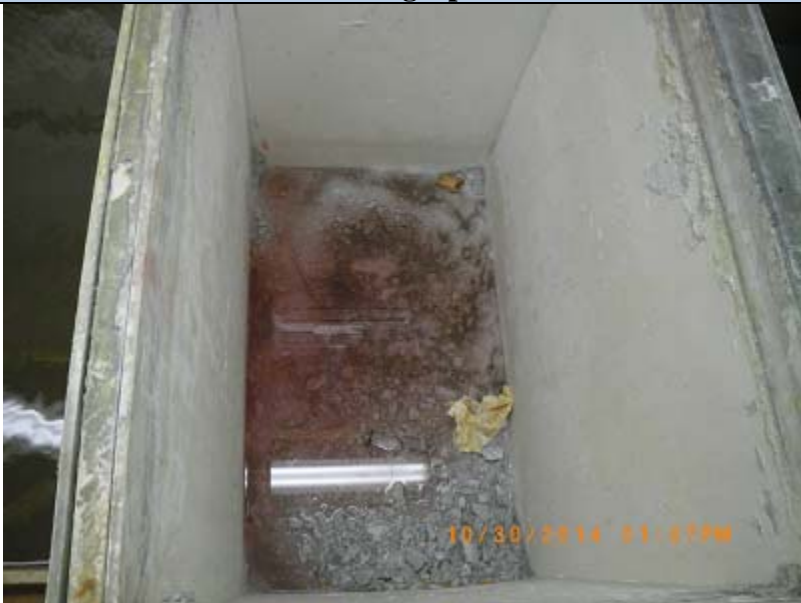
Observation	Photograph
<p>7. <i>Accumulated liquids and crystallization solids located in the bath shown in IMGP3937.</i></p>

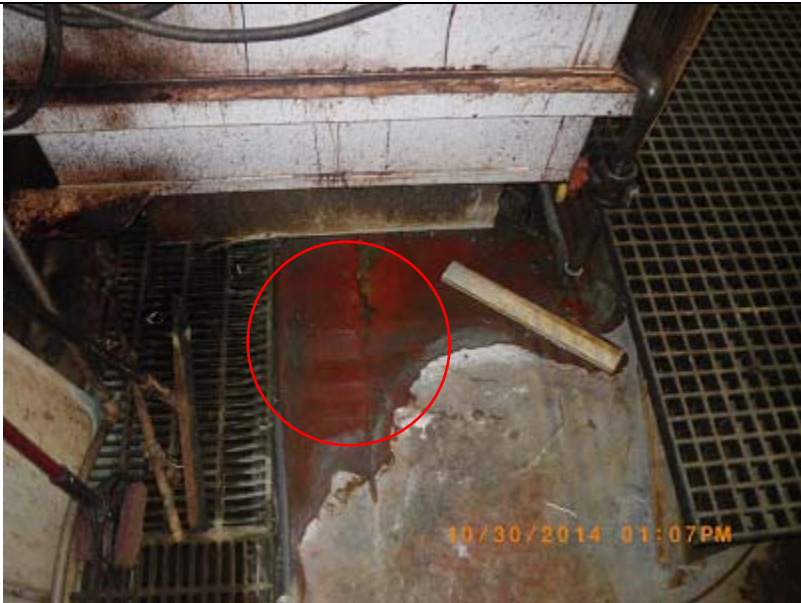
<p>No. 8 (IMGP3944)</p>

<p>No. 7 (IMGP3938)</p>
<p>8. <i>Accumulated metal plating or anodizing liquids draining into the facility's drainage system. Note the cracking on the surface (circled in red).</i></p>
